## PERFORMANCE EVALUATION OF THE ALMON STREET MULTI-UNIT RESIDENTIAL BUILDING

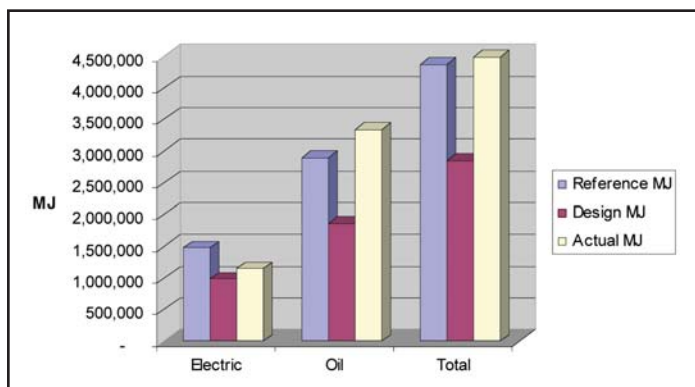
Figure 2: Annual Energy Consumption – Actual vs. Targets

Figure 2 shows the “Reference” MNECB, “Design” Target and “Actual” annual energy consumption for each energy source and in total. The actual electricity consumption was 22.3 per cent below the MNECB (“Reference”) and is 16.7 per cent higher than the design target (“Design”). The actual oil consumption was 15.0 per cent higher than the reference MNECB building and 78.8 per cent higher than the design target. Subsequent analysis of the energy loads and the building itself indicate that the discrepancy between the targets and actual performance may have been due to higher-than-anticipated electricity plug loads, high domestic hot water consumption and boiler/space heating system controls.

It is of interest to note that while the building failed to meet CBIP and MNECB targets, the total normalized annual energy consumption was only 158 ekWh/m<sup>2</sup>. This compares well with the average annual consumption—278 ekWh/m<sup>2</sup>—of other multi-unit residential buildings contained in the CMHC HiSTAR database.
